# Asbestos Minerals Sites – Initial Screening

Conducted by North Carolina Division of Waste Management,  
in cooperation with US EPA Region IV and North Carolina  
Division of Public Health, Health Hazards Control Unit

<b>A. SITE INFORMATION</b> Site Number: NC-49				
Historical Name	Sylva- US 23 Bypass Dunite			
Latitude / Longitude	35.38369N -83.20202W			
State, County, nearest City/Town	North Carolina, Jackson County, Sylva			
Site Type	<input type="checkbox"/> Mine	<input type="checkbox"/> Prospect	<input type="checkbox"/> Occurrence	
Mineral reported	<input type="checkbox"/> chrysotile	<input type="checkbox"/> crocidolite	<input type="checkbox"/> tremolite	<input checked="" type="checkbox"/> Other (name)
	<input type="checkbox"/> amosite	<input type="checkbox"/> anthophyllite	<input type="checkbox"/> actinolite	Fibrous talc and brucite

# Sylva- US 23 Bypass Dunitite

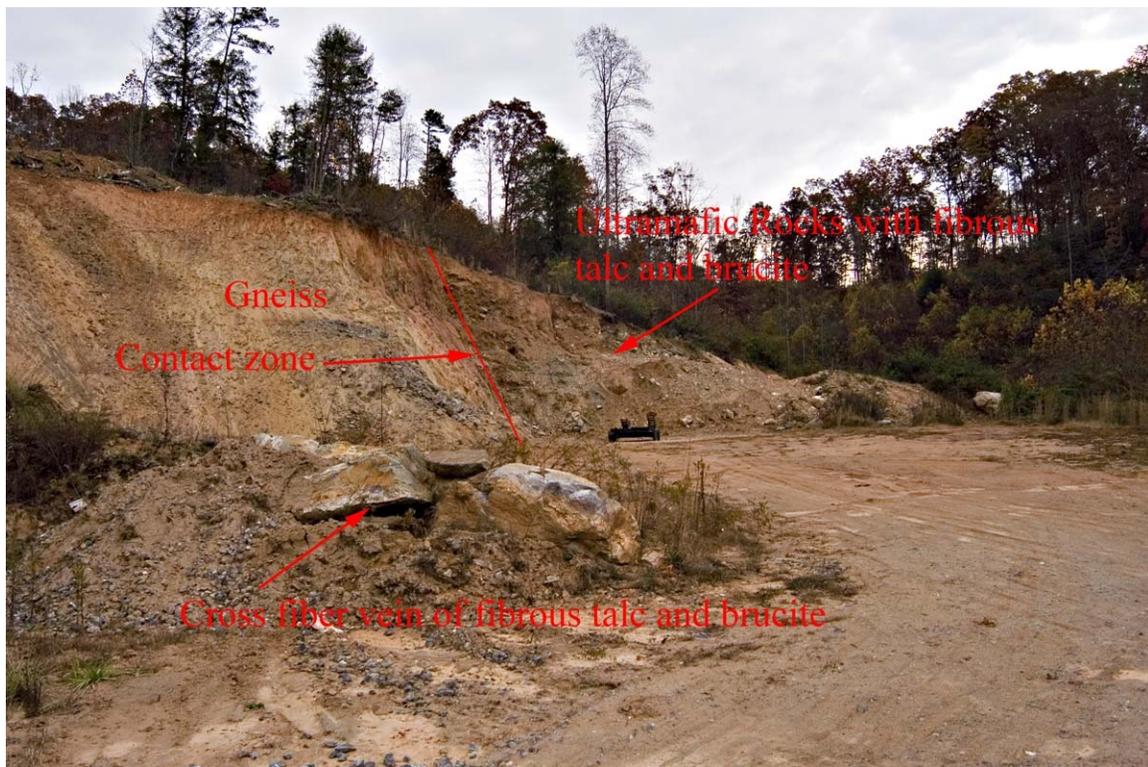
View borrow pit on east side of US 23 Bypass at the Sylva city limits.

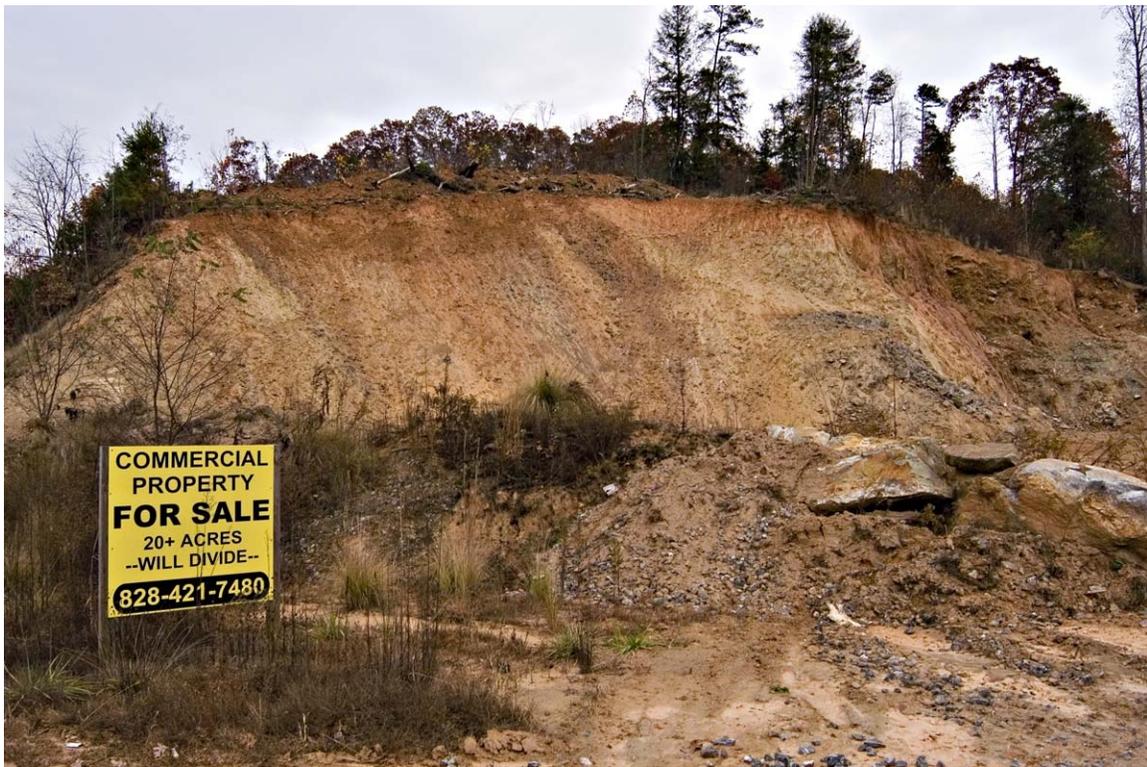
The property is for sale as commercial lots.

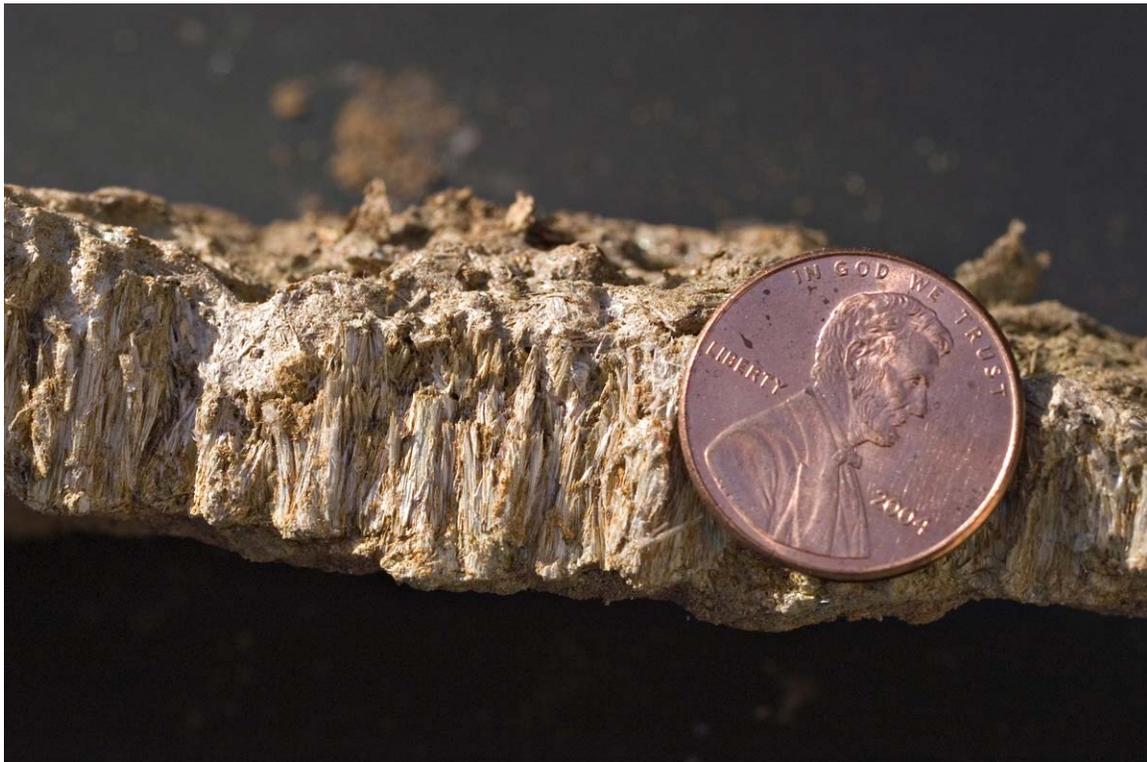
Cross-fiber vein of talc and brucite from boulder near US 23 Bypass.

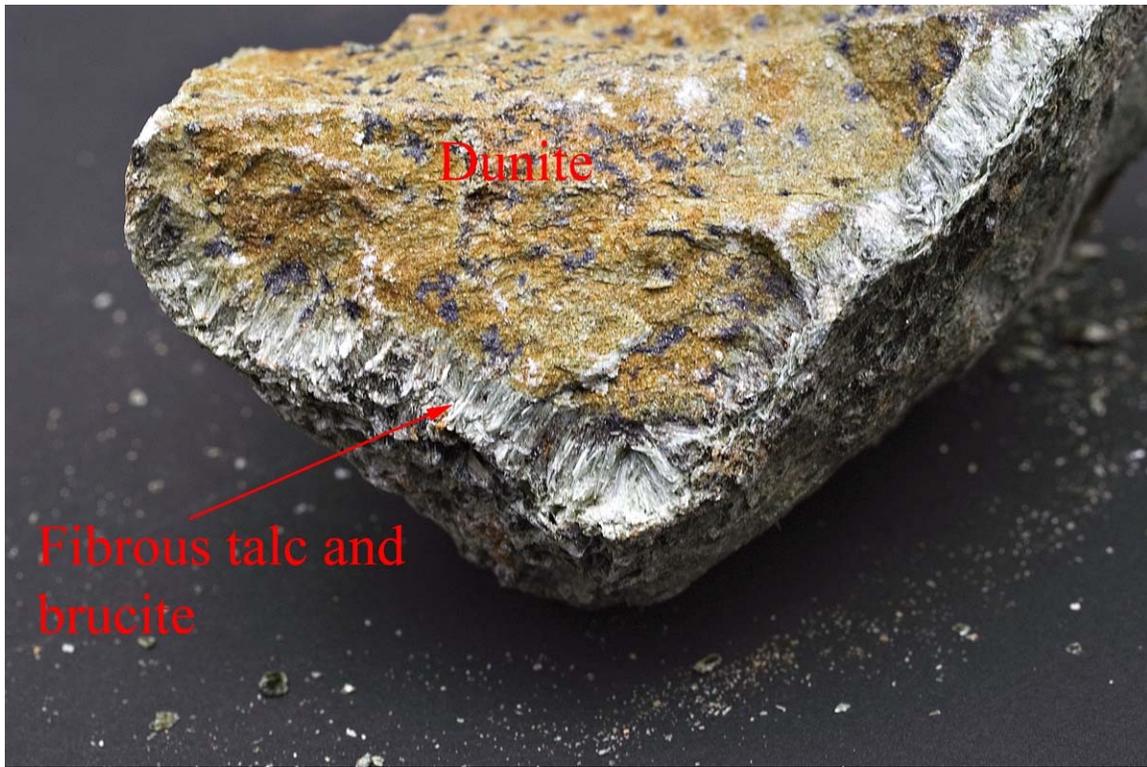
Dunite with alteration rind of talc and brucite from.

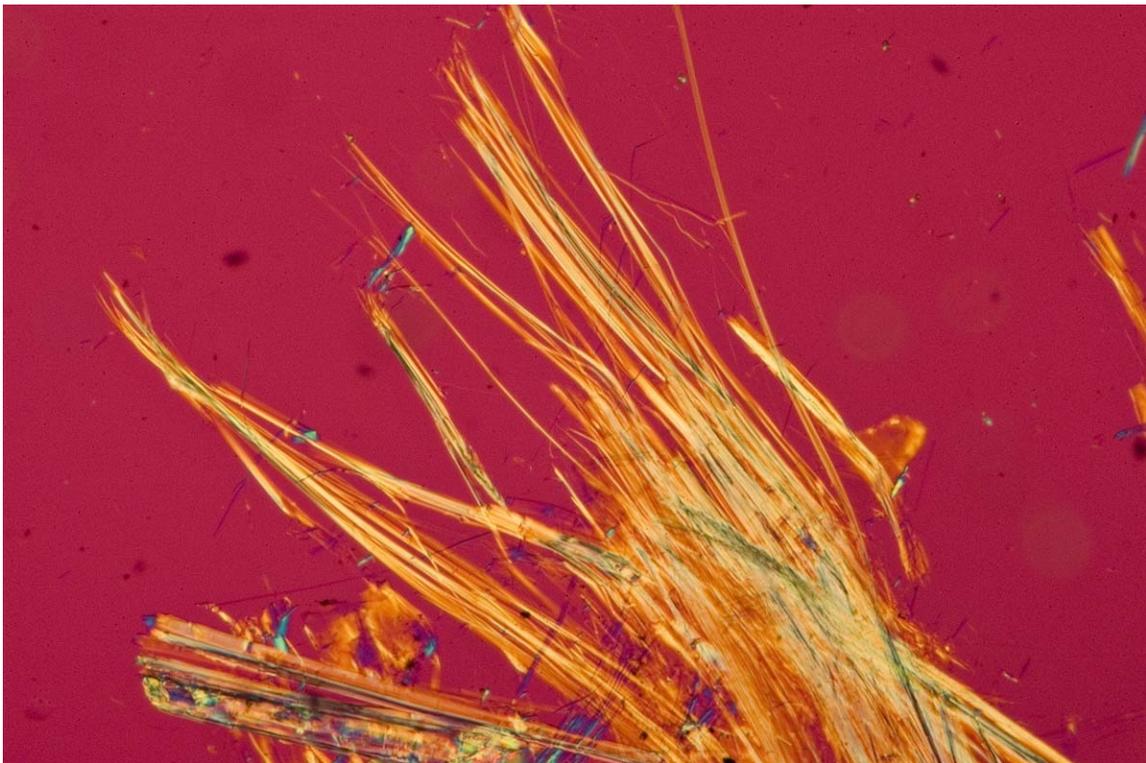
Fibrous talc as viewed through the polarizing light microscope using a gypsum plate.
