# Asbestos Minerals Sites – Initial Screening

<b>A. SITE INFORMATION</b> <b>Site Number: NC-42</b>			
Historical Name	Spruce Pine Unnamed Occurrences		
Latitude / Longitude	35.896N -82.065W		
State, County, nearest City/Town	North Carolina, Mitchell County, Spruce Pine		
Site Type	<input type="checkbox"/> Mine	<input type="checkbox"/> Prospect	<input checked="" type="checkbox"/> Occurrence
Mineral reported	<input type="checkbox"/> chrysotile	<input type="checkbox"/> crocidolite	<input type="checkbox"/> tremolite
	<input type="checkbox"/> amosite	<input checked="" type="checkbox"/> anthophyllite	<input type="checkbox"/> actinolite
	<input type="checkbox"/> Other (name) _____

# Spruce Pine Unnamed Prospects

Mitchell County

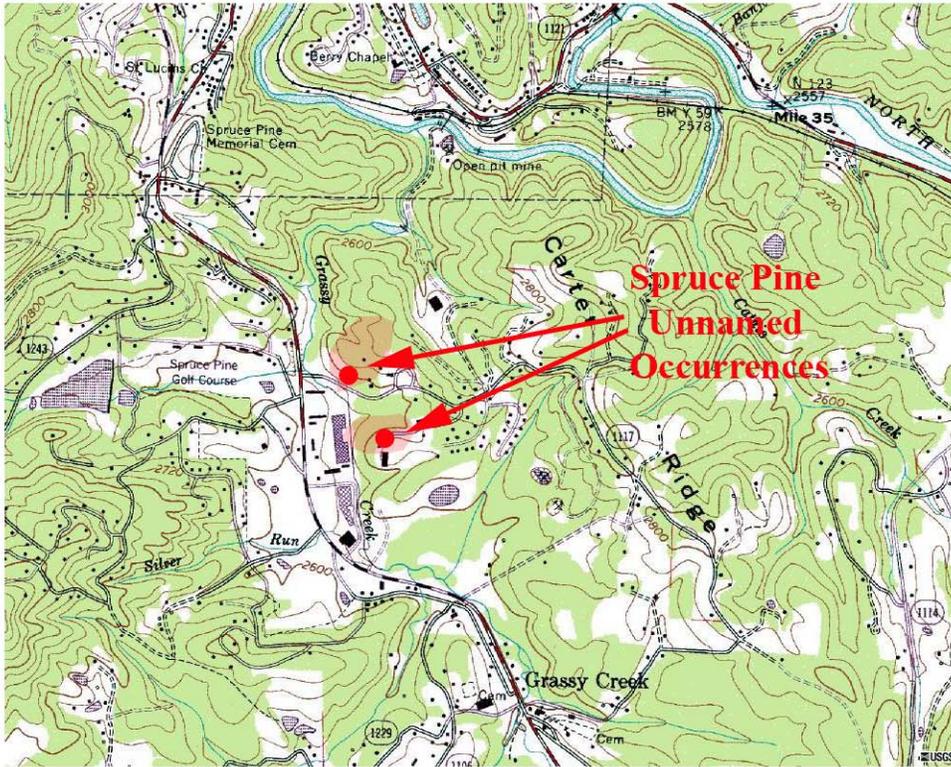
USGS Topographic Map: Spruce Pine 7.5' Quadrangle 7-1-94

Approximate Location of Ultramafic Rocks  
(After Conrad and others, 1963)

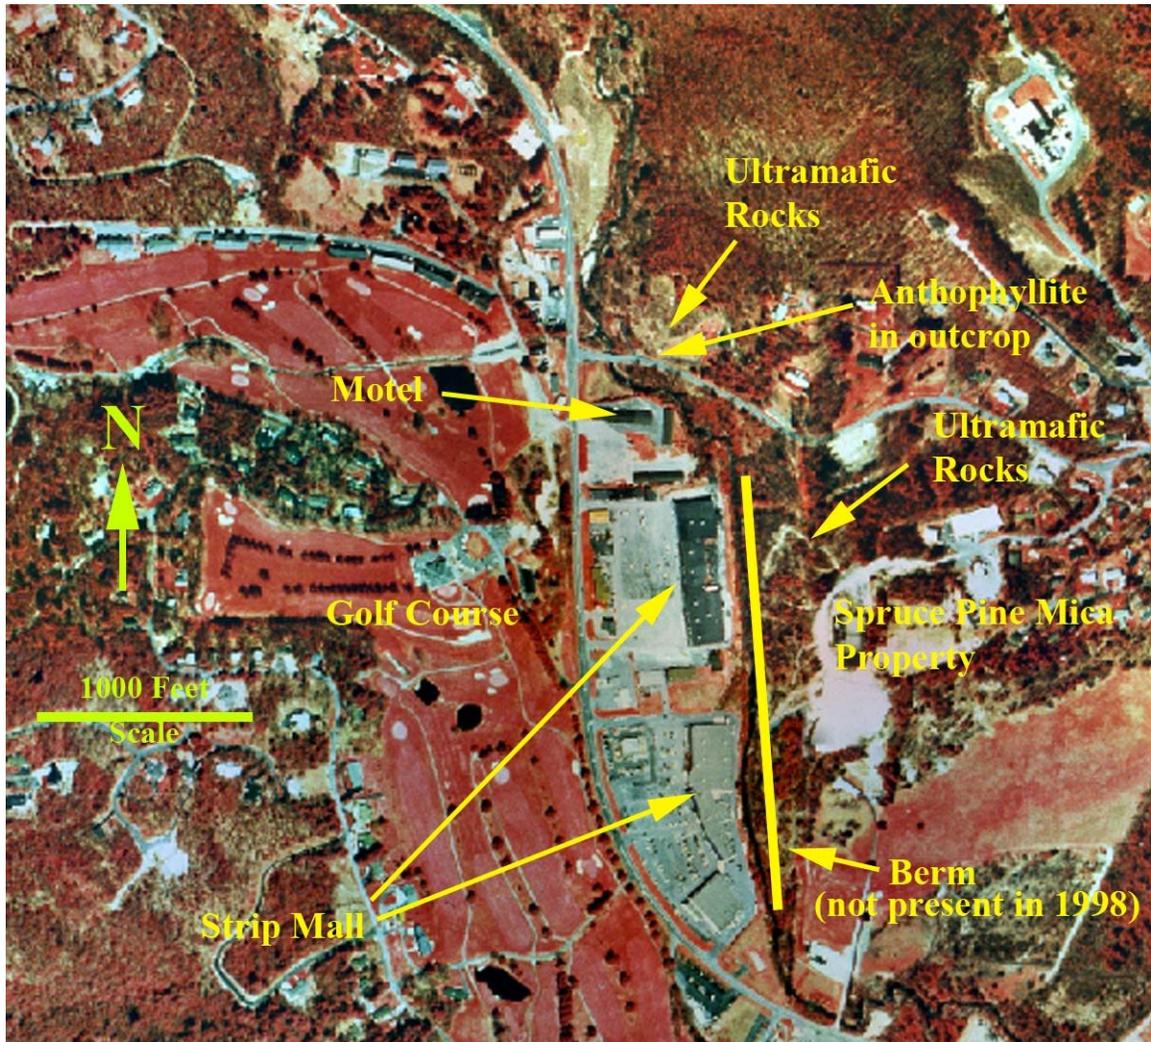
Color IR Orthophoto of the Spruce Pine unnamed anthophyllite occurrences area (1998).

**C4.** A lot is being graded in preparation for possible construction on the southwest end of the northern ultramafic body. Bare soil may be exposed in the vicinity of the southern ultramafic body on the Spruce Pine Mica Company property as indicated by the latest aerial photography inspected (1998). The berm behind the shopping mall appears to be well grassed.

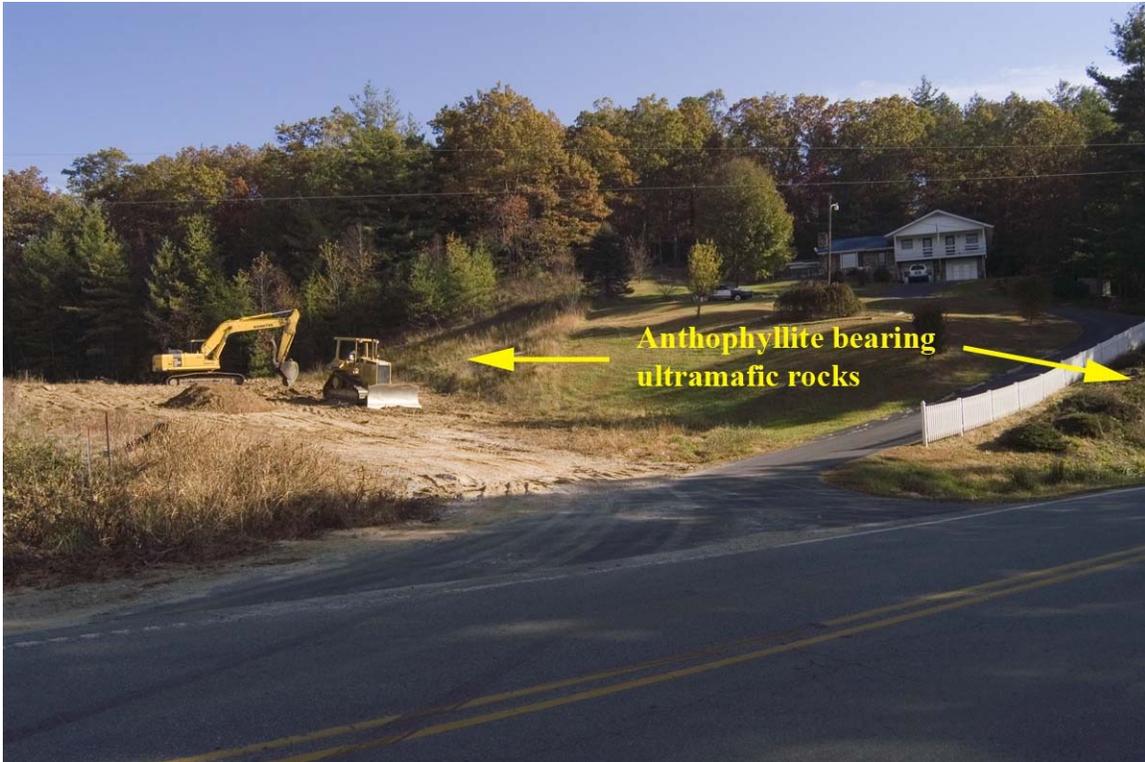
View looking north from SR 1117 toward the northern ultramafic body.

**C5.** At least three homes are located on the northern ultramafic body and grading is in progress for possibly more construction there. Visual inspection of the southern asbestos-bearing ultramafic body was not possible due to limited access to the Spruce Pine Mica Company property (locked gate).

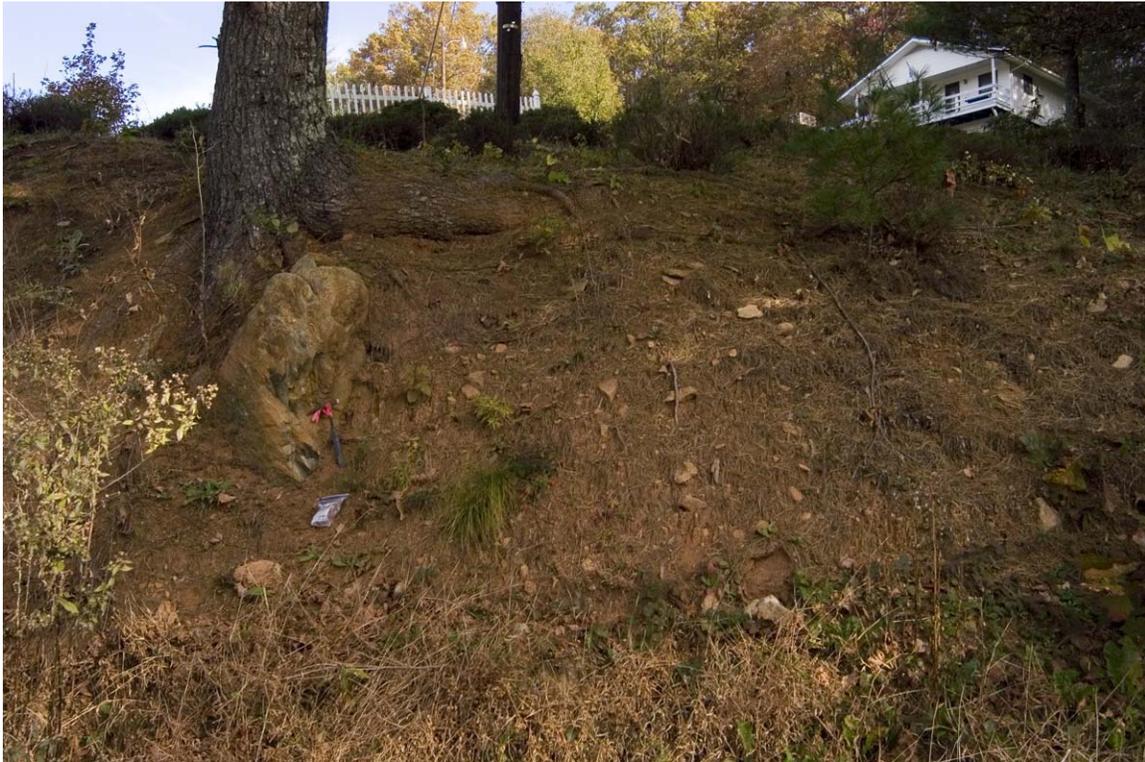
Outcrop on SR 1117 contains rocks with abundant anthophyllite.

**A.** Anthophyllite was identified in samples taken from a roadcut on State Road 1117. The anthophyllite comprises a high percentage of the rocks in this area. It is of the mass-fiber variety (compact, short-fiber, randomly oriented, fiber bundles). Initial PLM analysis was performed by Ronald D. McDaniel. Confirmation analysis by PLM was performed by Stephen H. Westbrook, Asbestos Analysis and Information Service, Inc., a NVLAP accredited laboratory

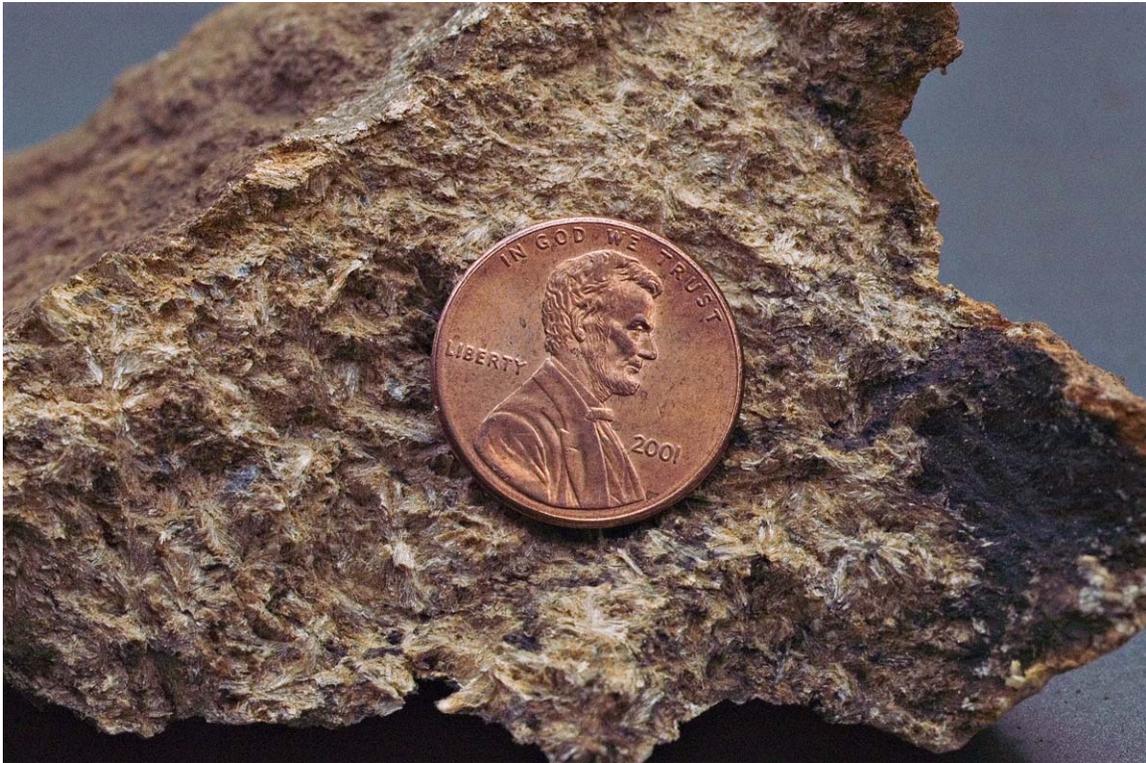
Anthophyllite in the SR 1117 outcrop occurs in dense, compact masses in which the fiber bundles have a random orientation.

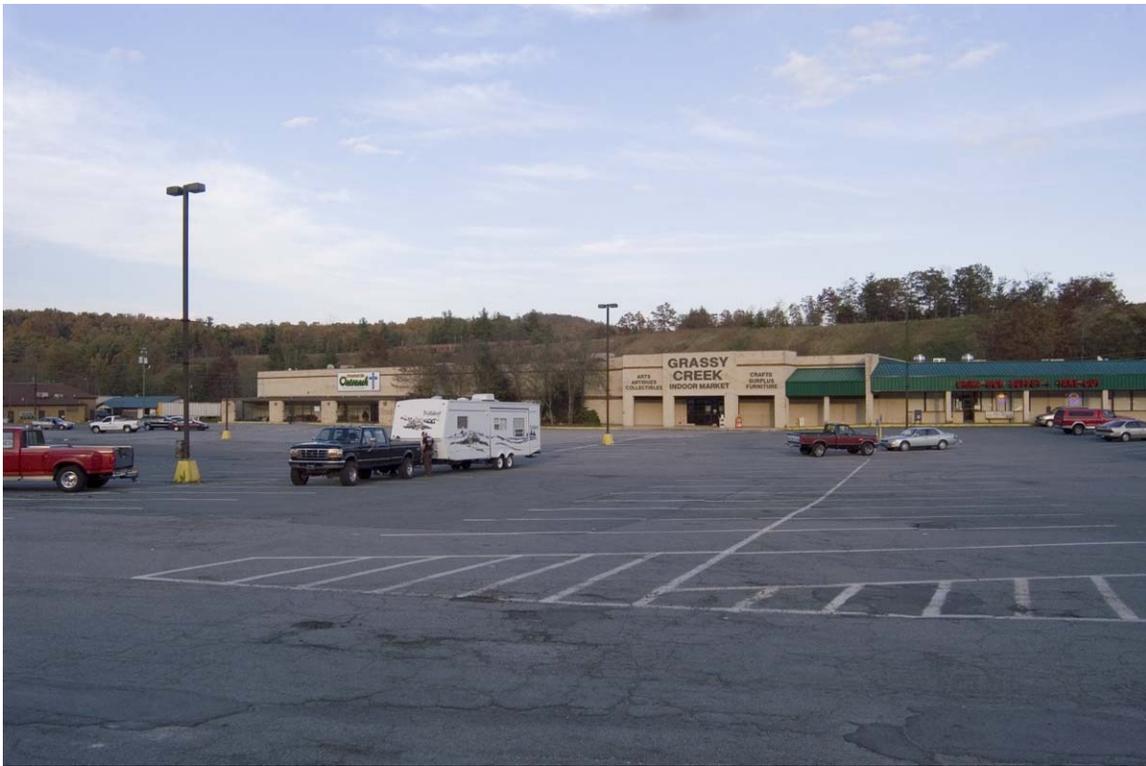
High berm behind strip mall was constructed a few years ago (since 1998). The southern Ultramafic body lies just behind this part of the shopping center according to mapping by Conrad and others (1963) and Brobst (1962).
